## Inspection Checklist for 2022 Kubota SSV75

Model: 2022 KUBOTA SSV75  
Machine Hours: 76  
Condition: Good (almost new condition)

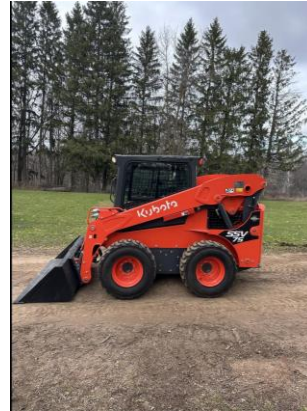
This Kubota SSV75 skidsteer is in excellent condition, reflecting its low usage of only 76 hours. All systems, components, and features are fully functional. The machine is work-ready with no immediate maintenance required.
