Inspection Checklist for 2022 TAKEUCHI TL10V2

- **Model:** 2022 TAKEUCHI TL10V2
- **Machine Hours:** 1,527

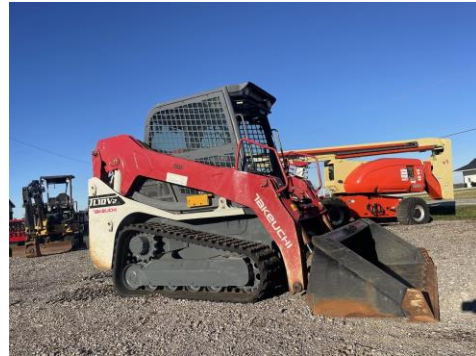
- **Exterior Condition:** No significant dents, rust, or damage; paint and decals intact.
- **Cab Condition:** Clean and well-maintained; seat, controls, and switches free of excessive wear.
- **Bucket Condition:** 80" bucket shows minimal wear; cutting edge intact with no cracks or excessive wear.

The 2022 TAKEUCHI TL10V2 skid steer with 1,527 hours is in **good condition** and operates as intended. All major components, including the hydraulic system, tracks, operator controls, and engine, have been inspected and found to be in proper working order. The new tracks and well-maintained auxiliary systems enhance the machine's value. No significant repairs or maintenance are required at this time.
