Albatross Equipment Earthworks
10998 WY-789 Riverton, WY 82501
www.albatrosequipment.com

Inspection Checklist for 2016 JCB 510-56

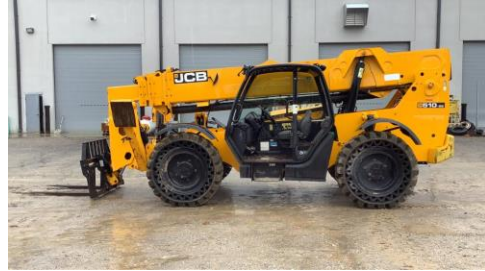
The 2016 JCB 510-56 Telehandler has been thoroughly inspected and is in good overall condition. Minor wear is consistent with its usage hours, and all critical systems are operational. The equipment is work-ready with no immediate repairs needed.
