Albatross Equipment Earthworks
10998 WY-789 Riverton, WY 82501
www.albatrosequipment.com

Inspection Checklist for 2018 CATERPILLAR 304E2 CR

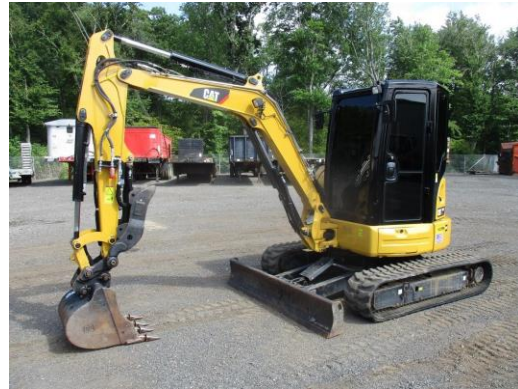
The 2018 Caterpillar 304E2 CR is in good condition with minimal wear consistent with the reported hours (534). No significant issues or immediate maintenance requirements were identified during this inspection. This excavator is work-ready and fully operational across all systems.
