Albatross Equipment Earthworks
10998 WY-789 Riverton, WY 82501
www.albatrossequipment.com

Inspection Checklist for 2019 BOBCAT E145

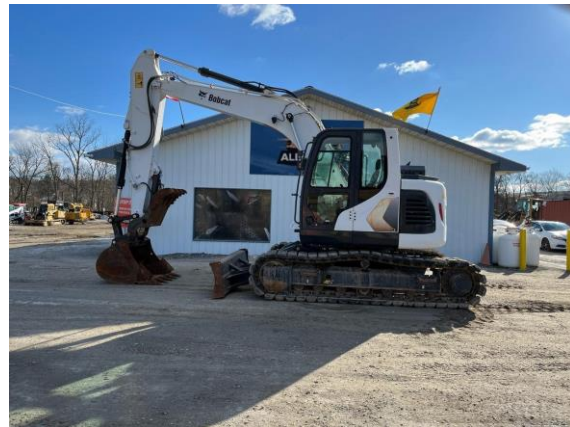
Equipment Details

Model: 2019 BOBCAT E145

Hours: 962

Condition: Good

Engine: 115 HP Perkins Diesel

Tracks: 20" Steel Tracks

Bucket: 42" Tooth Bucket

Auxiliary Hydraulics: Yes

Hydraulic Thumb: Yes

Max Digging Depth: 19'7"

Operating Weight: 34,987 lbs
