Albatross Equipment Earthworks
10998 WY-789 Riverton, WY 82501
www.albatrossequipment.com

Inspection Checklist for 2019 BOBCAT E26

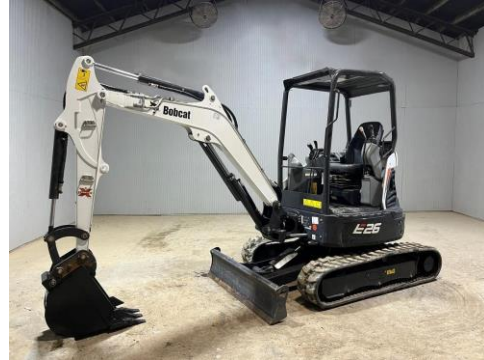
- Model: 2019 BOBCAT E26
- Hours: 266
- Condition: Good
- Specifications:
 - - Open Station w/ Canopy
 - - 2 Speed Travel
 - - AUX Hydraulics
 - - 61" Backfill Blade
 - - 27 HP Kubota Diesel Engine
 - - 14" Tooth Bucket
 - - Mechanical Coupler
 - - 12" Rubber Tracks
 - - 8'6" Max Digging Depth
 - - 6,239 lbs Operating Weight

The 2019 BOBCAT E26 is in ****good working condition****. All inspected components are operational and meet standard performance expectations. Tracks and hydraulic systems show minimal wear for the machine's hours. Routine maintenance is up-to-date. No immediate repairs or replacements are required.
