Inspection Checklist for 2019 Kubota U35-4

- - Model: 2019 KOMATSU PC138US LC-11
- - Hours: 4,452
- - Condition: Good Condition
- - Features: Enclosed Cab (EROPS), 27 1/2" Wide Tracks, 24" Bucket

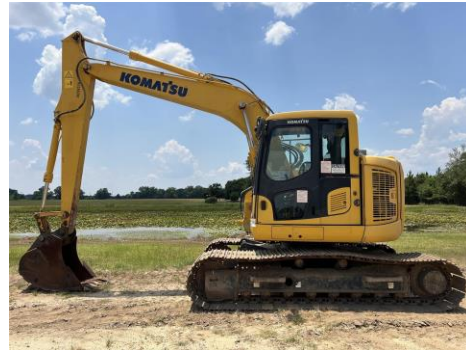
Equipment Information

The 2019 Komatsu PC138US LC-11 excavator is in **good condition**. All systems, including the boom, arm, bucket, hydraulic components, undercarriage, swing motor, engine, and cab, are operational and within normal working parameters. Moderate wear is present on the undercarriage and bucket teeth, but they retain
