Albatross Equipment Earthworks
10998 WY-789 Riverton, WY 82501
www.albatrossequipment.com

Inspection Checklist for 2019 Kubota U27-4

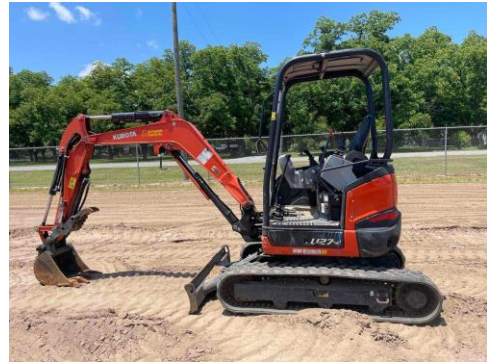
This 2019 Kubota U27-4 excavator is in good condition, with all major components inspected and found to be functional. Minor wear consistent with machine hours is present, but no immediate repairs or maintenance are required beyond routine service intervals.
