**Albatross Equipment Earthworks**  
10998 WY-789 Riverton, WY 82501  
[www.albatrossequipment.com](http://www.albatrossequipment.com)

## Inspection Checklist for 2019 Caterpillar 299D2

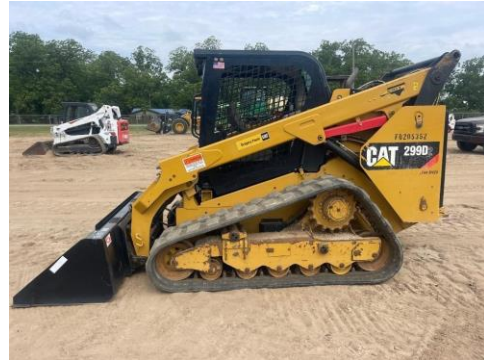
### Equipment Details:

**Model:** 2019 Caterpillar 299D2

**Features:** Rubber Tracks, OROPS, 2-Speed Travel, Quick Attach Bucket, Auxiliary Valves

The 2019 Caterpillar 299D2 is a good, clean working machine. The inspection reveals no major issues, with all components operating as intended. Tracks, hydraulics, and engine are in good condition, consistent with the machine's hours. Ready for immediate use.
