Inspection Checklist for 2020 DEERE 85G

Model: 2020 DEERE 85G

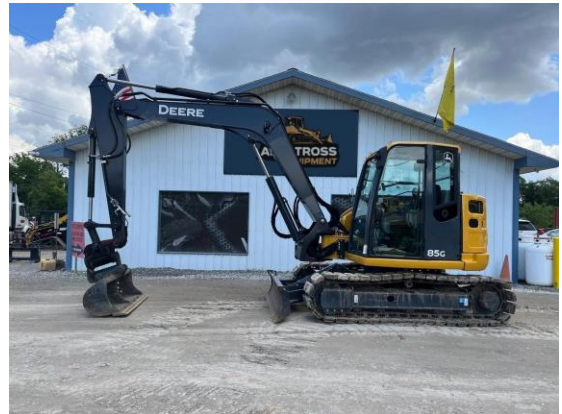
- - Enclosed Cab with Heat & Air, Radio
- - 2-Speed Travel
- - AUX Hydraulics
- - 86" Backfill Blade
- - 56.9 HP Yanmar Diesel Engine
- - 60" Tilt Bucket
- - 18" Rubber Padded Tracks
- - 14'10" Max Digging Depth
- - 19,244 lbs Operating Weight
