Albatross Equipment Earthworks
10998 WY-789 Riverton, WY 82501
www.albatrossequipment.com

Inspection Checklist for 2021 KOMATSU PC138US LC-11

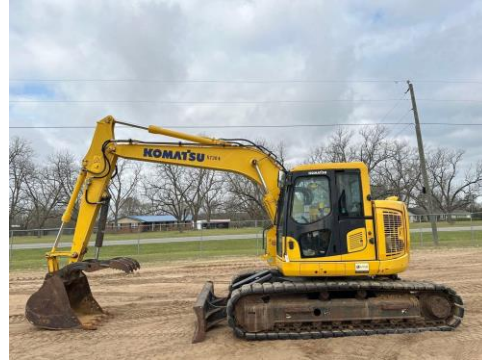
- Model: 2021 KOMATSU PC138US LC-11
- Hours: 1,578
- Condition: Good condition
- Features: Enclosed Cab (EROPS), Push Blade, 42" Bucket, Hydraulic Thumb
