**Albatross Equipment Earthworks**  
10998 WY-789 Riverton, WY 82501  
[www.albatrossequipment.com](http://www.albatrossequipment.com)

## Inspection Checklist for 2023 BOBCAT E88

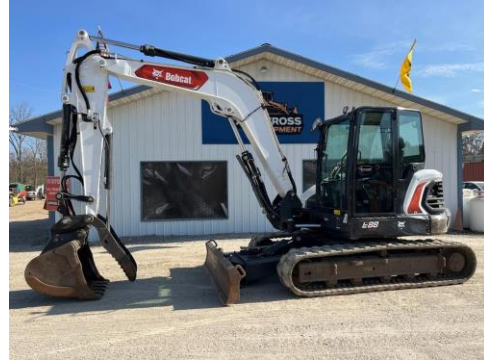
- Model: 2023 BOBCAT E88
- Hours: 1,127
- Condition: Good
- Specifications:
  - Enclosed Cab with Heat & Air, Radio
  - 2-Speed Travel
  - Hydraulic Thumb
  - Auxiliary Hydraulics
  - 86" Hydraulic Angle Backfill Blade
  - 65 HP Doosan Diesel Engine
  - 34" Tooth Bucket
  - Power Coupler
  - 18" Rubber Tracks
  - Max Digging Depth: 15'3"
  - Operating Weight: 19,600 lbs
