## Inspection Checklist for 2019 Caterpillar 239D3

Model: Caterpillar 239D3

Year: 2019

Hours: 1,778

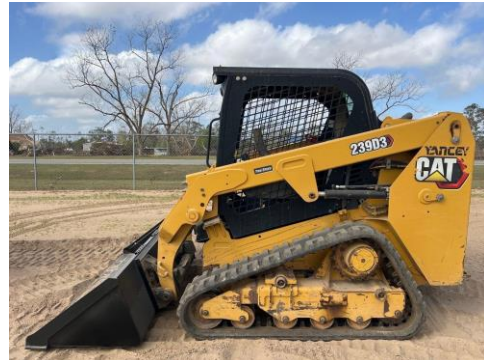
Condition: Good Condition

The 2019 Caterpillar 239D3 Skidsteer has been thoroughly inspected and is in good operational condition. Minor wear is consistent with machine hours (1,778) and does not impact performance. All major systems—engine, hydraulic, undercarriage, and drivetrain—are fully functional. The machine is work-ready and requires no immediate repairs or maintenance.
