Albatross Equipment Earthworks
10998 WY-789 Riverton, WY 82501
www.albatrossequipment.com

Inspection Checklist for 2019 CATERPILLAR 239D3

Model: 2019 Caterpillar 239D3

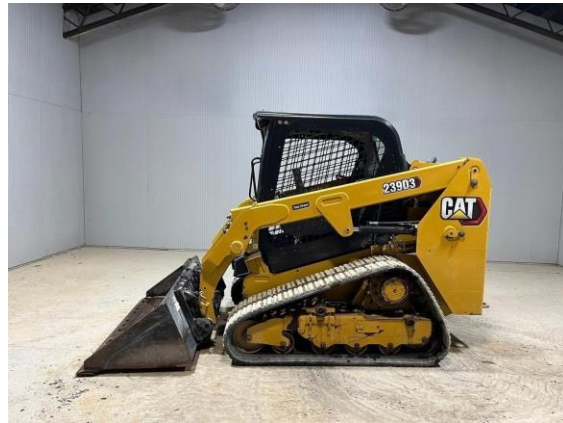
- OROPS
- Pilot Controls
- 2-Speed Travel
- Auxiliary Hydraulics
- 67.1 HP Caterpillar Diesel Engine
- 74" General Purpose Bucket
- SSL Quick Attach System
- 16" Rubber Tracks
- 1,530 lbs Lift Capacity
- 7,434 lbs Operating Weight

The 2019 Caterpillar 239D3 is in good condition with no major defects or issues detected during the inspection.
