Inspection Checklist for 2019 Kubota SVL75-2

Equipment Model: 2019 Kubota SVL75-2

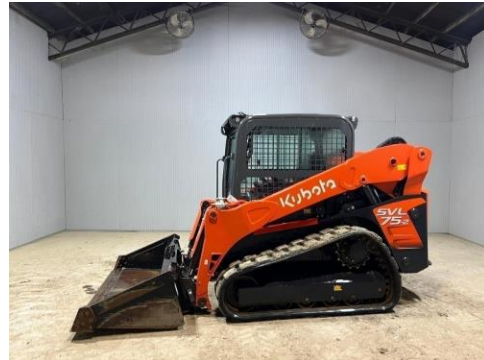
Features: OROPS, Pilot Controls, 2 Speed, Auxiliary Hydraulics, 74 HP Kubota Diesel Engine, New 72" HD Bucket, Hydraulic SSL Quick Attach, 16" Rubber Tracks, 2,282 lbs Lift Capacity, 9,039 lbs Operating Weight
