Inspection Checklist for 2020 Kubota SVL75-2

Model: 2020 Kubota SVL75-2

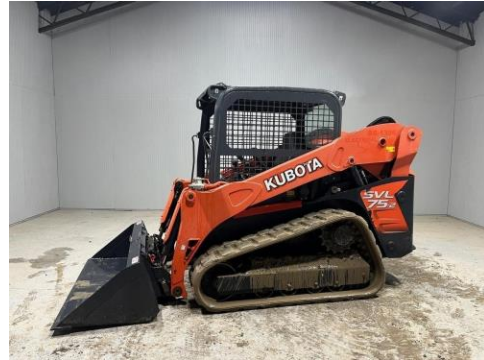
Features: OROPS, Pilot Controls, 2 Speed, AUX Hydraulics, 74.3 HP Kubota Diesel Engine, New 72" HD Bucket, Hydraulic SSL Quick Attach, 16" Rubber Tracks, 2,282 lbs Lift Capacity, 9,039 lbs Operating Weight
