Albatross Equipment Earthworks
10998 WY-789 Riverton, WY 82501
www.albatrossequipment.com

Inspection Checklist for 2021 Kubota SCL1000

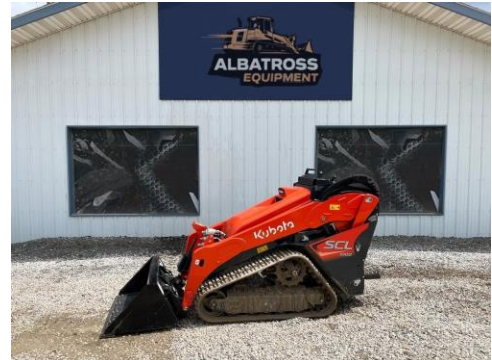
- **Model:** 2021 Kubota SCL1000
- **Machine Hours:** 90
- **Condition:** Good
- **Specifications:**
 - Walk Behind w/ Riding Platform
 - Auxiliary Hydraulics
 - 24.8 HP Kubota Diesel Engine
 - 36" General Purpose (GP) Bucket
 - Mini SSL Quick Attach
 - 10" Rubber Tracks
 - 1,000 lbs Lift Capacity
 - 3,035 lbs Operating Weight

The **2021 Kubota SCL1000** is in **good condition**, showing minimal wear consistent with 90 hours of use. All systems are operational, with no leaks, cracks, or major defects. This machine is ready for immediate use in the field.
