Albatross Equipment Earthworks
10998 WY-789 Riverton, WY 82501
www.albatrossequipment.com

Inspection Checklist for 2021 Caterpillar 279D3

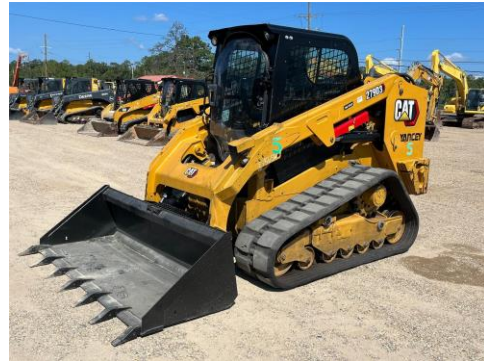
- **Model:** 2021 Caterpillar 279D3
- **Hours:** 2,633
- **Condition:** Good
- **Features:** Enclosed cab w/ air, hydraulic quick-connect GP bucket, rubber tracks.
