**Albatross Equipment Earthworks**  
10998 WY-789 Riverton, WY 82501  
[www.albatrossequipment.com](http://www.albatrossequipment.com)

## Inspection Checklist for 2022 Caterpillar 289D3

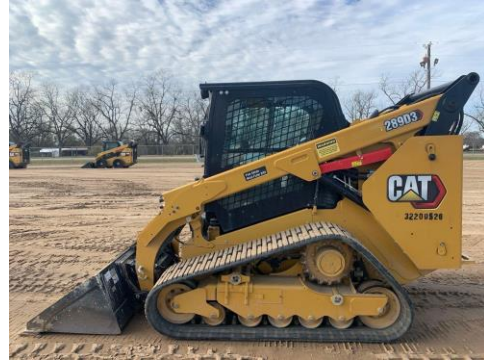
Model: 2022 Caterpillar 289D3

Features: Rubber track, EROPS, 2-speed, High Flow XPS, Hydraulic Quick Attach Bucket, Auxiliary Valves
