**Albatross Equipment Earthworks**  
10998 WY-789 Riverton, WY 82501  
[www.albatrossequipment.com](http://www.albatrossequipment.com)

## **Inspection Checklist for 2000 JOHN DEERE 7810**

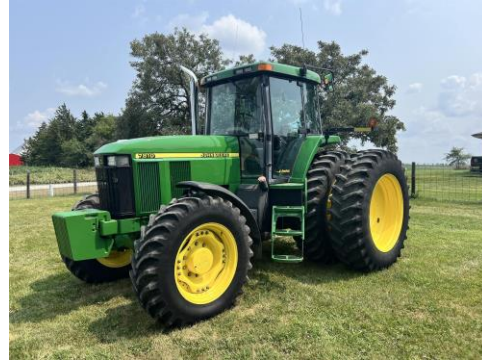
Tractor operated as it should during inspection with no visible mechanical issues.

Overall condition is **\*\*good\*\***, with minor cosmetic wear consistent with hours and age.
