Inspection Checklist for 2015 JCB 512-56

Inspection Summary

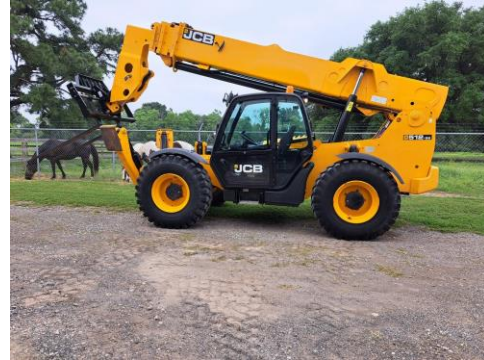
This 2015 JCB 512-56 Telehandler is in good condition and is fully operational. All critical systems have been inspected, and no issues were found that would prevent immediate use. The machine is ready for work and meets operational and safety standards.
