Albatross Equipment Earthworks
10998 WY-789 Riverton, WY 82501
www.albatrossequipment.com

Inspection Checklist for 2016 Bobcat T450

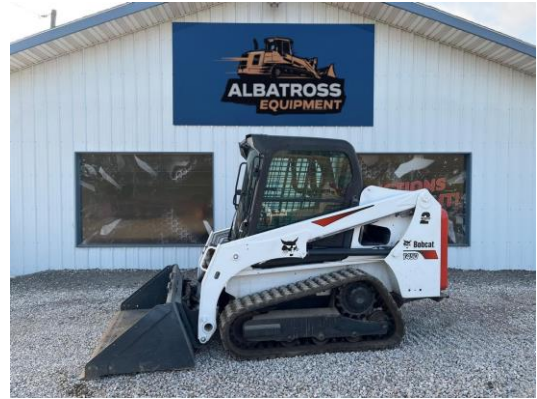
The 2016 BOBCAT T450 is in good condition and mechanically sound, with minimal wear for its age and usage. New rubber tracks provide excellent traction, and the hydraulic and engine systems are in optimal condition. Minor deficiencies noted include a non-functional air conditioning system due to a missing compressor. Overall, this Skidsteer is work-ready and requires no immediate repairs or maintenance beyond the optional A/C compressor replacement.

****Rating**:** 90% Condition

****Mechanic's Notes**:** This machine has been thoroughly inspected and is deemed suitable for heavy-duty operations. Buyer should consider addressing the A/C compressor replacement if cooling functionality is required.
