Albatross Equipment Earthworks
10998 WY-789 Riverton, WY 82501
www.albatrossequipment.com

Inspection Checklist for 2018 BOBCAT T770

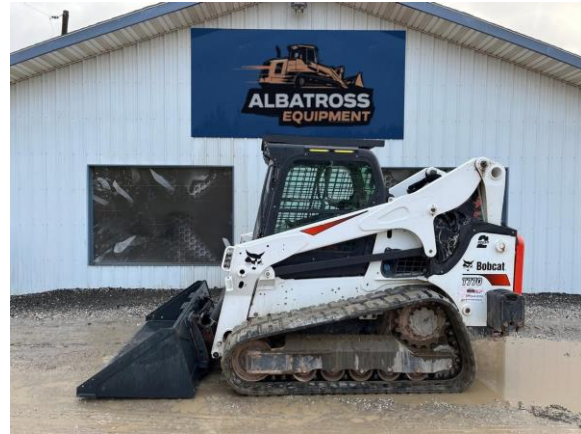
The 2018 BOBCAT T770 is in good condition, with all major systems operational. Minor wear is consistent with its usage hours (1,814). This machine is well-maintained, fully functional, and work-ready.
