Albatross Equipment Earthworks
10998 WY-789 Riverton, WY 82501
www.albatrossequipment.com

Inspection Checklist for 2018 DEERE 650K LGP

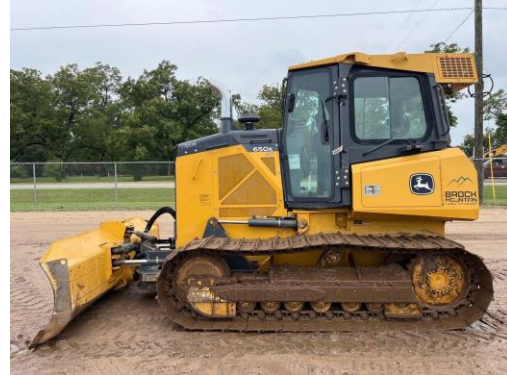
The ****2018 DEERE 650K LGP**** is in ****Good Condition****, with all major systems functioning properly. Minor wear noted on the cutting edge of the blade and undercarriage components, but these are within acceptable operational limits. The machine is ready for immediate use.
