Albatross Equipment Earthworks
10998 WY-789 Riverton, WY 82501
www.albatrossequipment.com

Inspection Checklist for 2020 CATERPILLAR 420F2

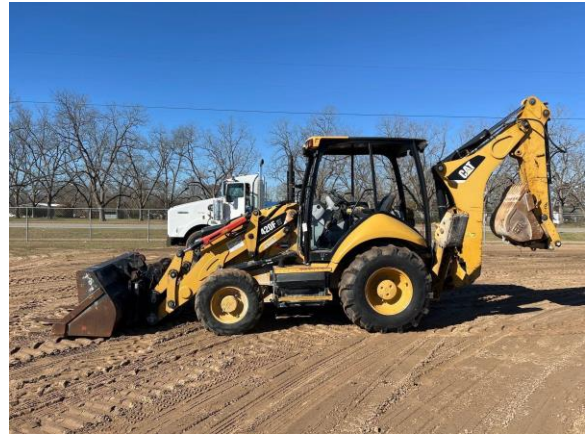
This 2020 CATERPILLAR 420F2 is in excellent condition, operating at 90% of its original performance. With 497 original hours, it is practically like new and ready for immediate use on a farm or job site. All systems have been thoroughly inspected and are fully operational, with no significant issues noted.
