Albatross Equipment Earthworks
10998 WY-789 Riverton, WY 82501
www.albatrossequipment.com

Inspection Checklist for 2020 DEERE 50G

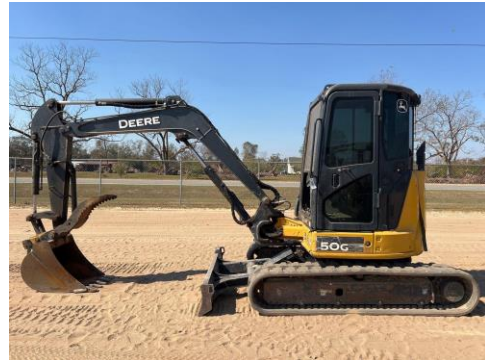
- Exterior Condition: Paint intact with minor wear consistent with usage. No visible structural damage.
- Operational Status: The machine starts and runs smoothly with no unusual noises or vibrations.

The 2020 DEERE 50G is in good condition overall. All major components, including the hydraulic system, undercarriage, engine, and cab, are operational and exhibit normal wear consistent with the machine's 1,091 hours of use. The machine is ready for work with no immediate maintenance needs identified.
