Albatross Equipment Earthworks
10998 WY-789 Riverton, WY 82501
www.albatrossequipment.com

Inspection Checklist for 2021 DEERE 26G

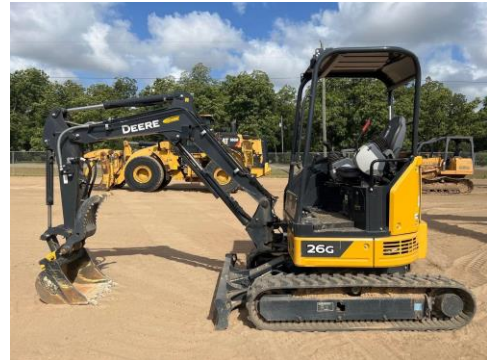
The 2021 DEERE 26G is in good condition with minimal wear and tear due to low operating hours. The rubber tracks, hydraulic systems, and engine components are well-maintained and in excellent working order. All inspected components meet operational standards, and the machine is fully operational without requiring immediate maintenance or repairs.
