## Inspection Checklist for 2023 BOBCAT E88R2

Model: 2023 BOBCAT E88R2

Hours: 715

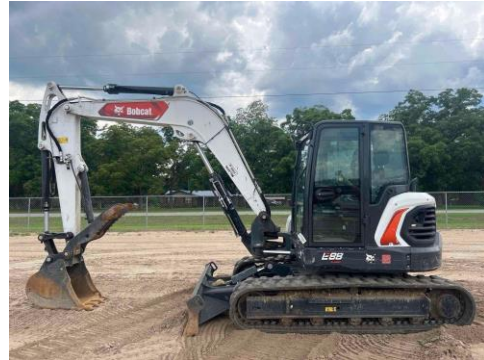
Condition: Good Condition

Features: Rubber Tracks, Enclosed Cab (EROPS), Push Blade, 24" Bucket, Hydraulic Thumb, Auxiliary Valves

The 2023 BOBCAT E88R2 is in good condition, with all major systems functioning as expected. No significant repairs are required at this time. Regular maintenance should be continued to ensure optimal performance.
