## Inspection Checklist for 2017 BOBCAT T750

2017 BOBCAT T750

Machine Hours: 999

Condition: Good

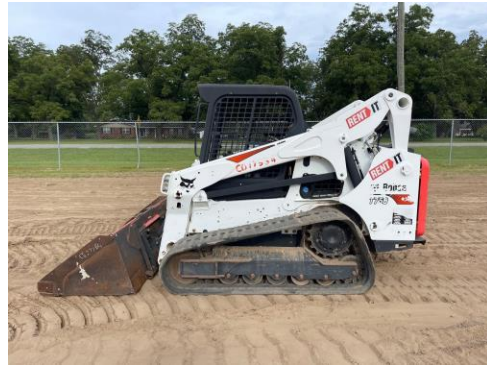
The 2017 BOBCAT T750 is in good condition, with all major components fully operational. Minor wear consistent with age and usage was noted on the paint and bucket. Tracks retain approximately 85% tread, and the hydraulic and powertrain systems show no leaks or performance issues. The machine is work-ready and requires no immediate maintenance or repairs.
