Inspection Checklist for 2019 JCB 270T

Model: JCB 270T
Year: 2019
Machine Hours: 1249
Condition: Good

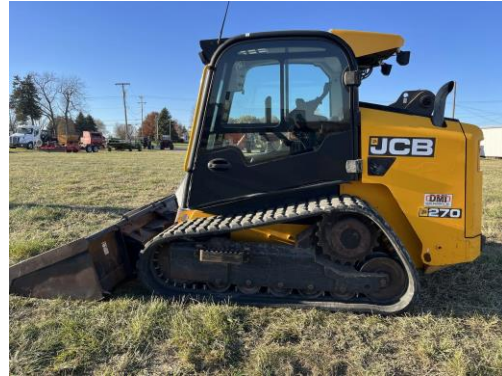
The 2019 JCB 270T Skidsteer has been thoroughly inspected and found to be in **good condition**, with all major components operating as intended. Minor wear is consistent with the machine's hours and usage. This equipment is ready for immediate use.
