Inspection Checklist for 2019 JCB 270T

- **Model:** 2019 JCB 270T
- **Machine Hours:** 855
- **Condition:** Good

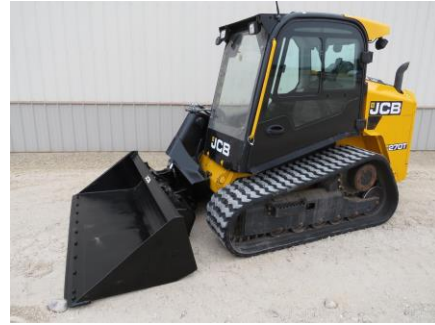
The 2019 JCB 270T skid steer has been thoroughly inspected and is in **good condition**, reflecting its low machine hours (855). Minor cosmetic wear is present but does not impact functionality. All systems, including the hydraulic quick attach, 2-speed transmission, and A/C, are fully operational. The machine is ready for immediate use.
