Inspection Checklist for 2019 BOBCAT T590

Model: 2019 BOBCAT T590
Machine Hours: 1,525
Condition: Good

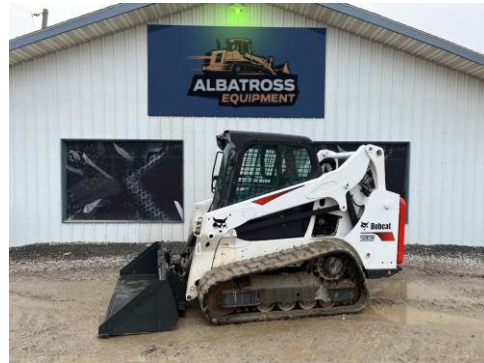
The **2019 BOBCAT T590** Skidsteer is in **Good Condition**, with all major systems operational and no significant issues detected. This machine has been maintained according to manufacturer specifications and is work-ready.
