Albatross Equipment Earthworks
10998 WY-789 Riverton, WY 82501
www.albatrossequipment.com

Inspection Checklist for 2019 Caterpillar 279D3

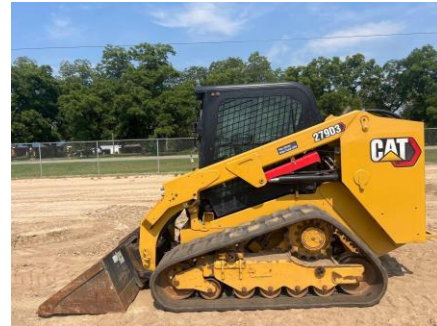
- Visual Inspection: No visible damage, rust, or excessive wear on the exterior.
- Paint Condition: Minor scratches consistent with normal use. No peeling or fading.
- Decals and Labels: Legible and securely affixed.

- Overall Assessment: This 2019 Caterpillar 279D3 is in good condition, with all systems functioning properly.
- Recommended Actions: None; machine is work-ready.
