Inspection Checklist for 2020 Caterpillar 279D3

- **Model:** 2020 Caterpillar 279D3
- **Machine Hours:** 675
- **Condition:** Good
- **Features:** Rubber Tracks, Enclosed ROPS (EROPS), 2-Speed, High Flow XPS, Hydraulic Quick Attach Bucket, Auxiliary Valves

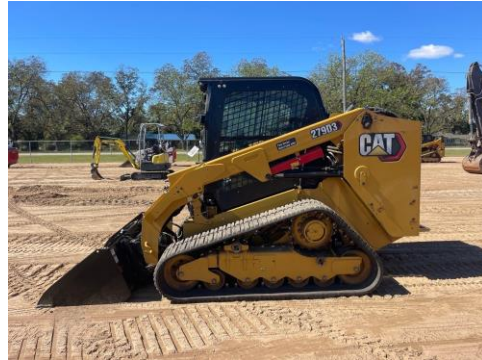
The 2020 Caterpillar 279D3 has been thoroughly inspected and is in **good condition**, with all major systems operational and well-maintained. Minor wear is consistent with usage, and the machine is fully work-ready.

- Routine maintenance is recommended within the next 100 hours to ensure continued performance.
- Monitor track wear and replace as needed to maintain optimal traction.
