## Inspection Checklist for 2020 JCB 3TS-8T

- **Model:** JCB 3TS-8T
- **Year:** 2020
- **Machine Hours:** 653
- **Condition:** Excellent

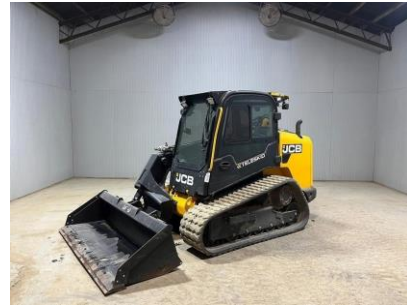
This 2020 JCB 3TS-8T Skidsteer is in **excellent condition** with no significant issues or repairs needed. The machine operates smoothly across all systems, with all critical components such as the hydraulic system, engine, and loader arms showing minimal wear. The tracks, boom, and attachments are in great shape, and the cab is well-maintained. No immediate maintenance is required at this time, but regular upkeep of hydraulic fluids, greasing, and checking for wear will help maintain the machine's performance and longevity.
