Inspection Checklist for 2021 Caterpillar 289D3

Model: 2021 Caterpillar 289D3

Hours: 1,568

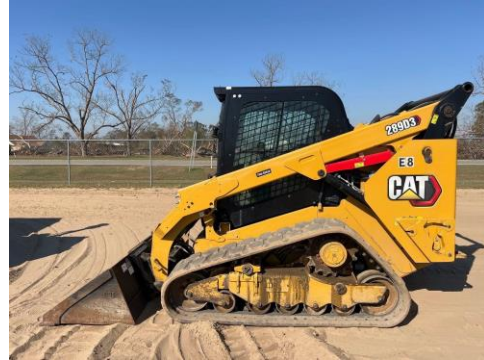
Condition: Good

The 2021 Caterpillar 289D3 Skidsteer is in good condition with 1,568 hours. All major systems have been inspected and are fully operational. The machine shows normal wear for its hours and is well-maintained, with no immediate repairs needed. This equipment is work-ready.
