## Inspection Checklist for 2021 John Deere 325G

**Model:** 2021 John Deere 325G

**Hours:** 260

**Condition:** Good

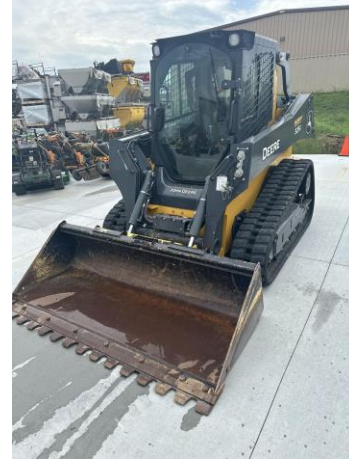
The 2021 John Deere 325G skid steer is in good condition with minor cosmetic wear consistent with its 260 operating hours. All systems, including the hydraulic, engine, undercarriage, and electrical, are functioning well. The machine is work-ready and requires no immediate maintenance.
