Inspection Checklist for 2021 JCB 270T

Model: 2021 JCB 270T
Machine Hours: 1,802

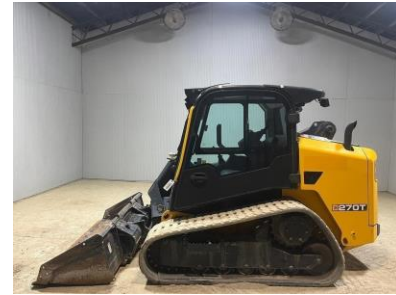
- **Overall Appearance:** The machine exterior is clean and shows no signs of excessive wear, dents, or structural damage. Minor surface scratches are present, consistent with normal use.
- **Cab Interior:** The operator cabin is clean, and all features (heat, air conditioning, radio) are functional.
- **Machine Hours:** Verified at 1,802.

The 2021 JCB 270T Skidsteer is in **good condition** with no significant mechanical or structural issues identified during the inspection. All systems and features are fully operational, and the machine is ready for work. Tracks show 75% tread remaining, and minor cosmetic wear is consistent with its 1,802 hours of use. Routine maintenance has been well performed, and no immediate repairs are required.
