Inspection Checklist for 2021 Kubota SVL95-2S

- **Model:** Kubota SVL95-2S
- **Year:** 2021
- **Machine Hours:** 596
- **Condition:** Good

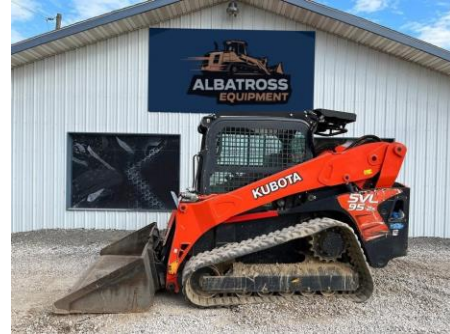
The **2021 Kubota SVL95-2S** is in **good condition**, with minor cosmetic wear and no significant mechanical or hydraulic issues. All systems are fully operational, and the machine is work-ready. With 596 hours of operation, this Skidsteer is well-maintained and reliable for heavy-duty use.
