Inspection Checklist for 2021 Caterpillar 299D3 XE

- Model: 2021 Caterpillar 299D3 XE
- Machine Hours: 1,536
- Condition: Good
- Features: EROPS, Heat & Air, Radio, Pilot Controls, 2-Speed, High Flow AUX Hydraulics, XE High Flow Hydraulics, Hydraulic Cooler, Rear Camera, 110 HP Caterpillar Diesel Engine, New 78" HD Bucket, Hydraulic SSL Quick Attach, 16" Rubber Tracks, 3,560 lbs Lift Capacity, 11,756 lbs Operating Weight

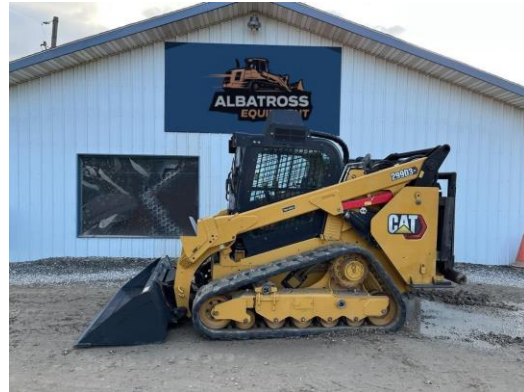
The 2021 Caterpillar 299D3 XE has been thoroughly inspected and is in good condition. Minor cosmetic wear consistent with hours and age is present but does not affect performance. All systems and components are functional and meet manufacturer specifications. This skidsteer is work-ready and well-maintained.
