Inspection Checklist for 2022 TAKEUCHI TL12R2

- **Make & Model:** 2022 TAKEUCHI TL12R2
- **Machine Hours:** 776

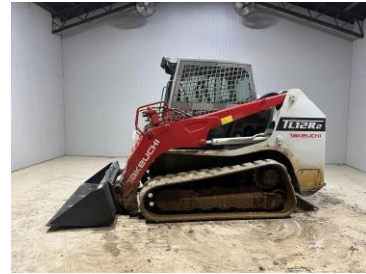
This 2022 TAKEUCHI TL12R2 is in **excellent condition** and fully operational. With only 776 hours of use, it shows minimal wear and includes a brand-new heavy-duty bucket. All systems, including hydraulics, engine, and tracks, are performing optimally. This machine is work-ready and well-suited for heavy-duty tasks.
